New Techniques to ID COUNTERFEIT ICs

Acoustic micro imaging can reveal whether the die and lead frame are genuine.

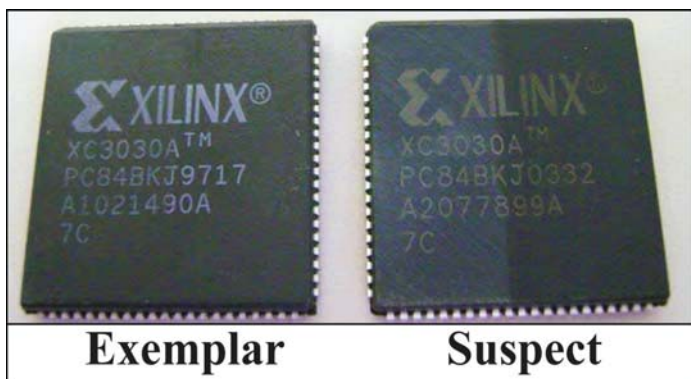
FIGURE 1. New technique removes highly engineered blacktop from counterfeit at right without changing surface of genuine component at left.

This new advanced blacktop material is harder to distinguish visually from the surface of a genuine part, and is not affected whatsoever by traditional RTS test methods. An engineer applying traditional solvent testing would conclude it to be a genuine part. SMT believes this advanced blacktop material is made from the dust ground off components and then mixed with a heat-activated epoxy compound before being sprayed on and heat-cured for hardness and durability. In September 2009, Honeywell Aerospace shared its process using a heated solvent called “Uresolve” (made by Dynaloy) that proved effective in removing the new blacktop coating from counterfeit components. The only major drawback to

In January, SMT Corp. further refined that process using a different Dynaloy product called DynaSolve 750. After considerable experimentation on a wide range of counterfeit and authentic parts, a temperature/duration process was identified that completely removed the new blacktop (exposing the sanding marks below) – yet had no effect on the factory-applied topcoats of all authentic components tested. The refined process required the DynaSolve be preheated to 105°C and the suspect component to be half-immersed for 45 min. (FIGURE 1).

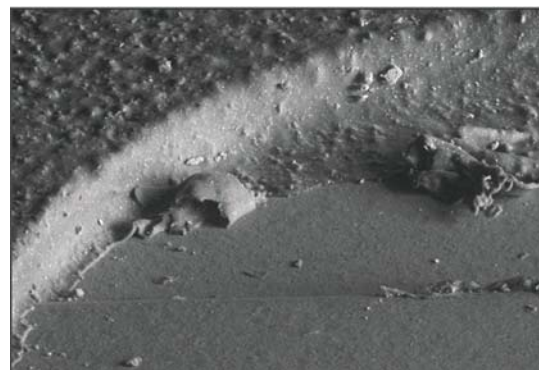
FIGURE 2. SEM image shows highly engineered blacktop material within pin-one cavity. (Photo courtesy Tescan USA)

visibly coated the upper portion of the side of the component. In addition, the blacktop material had in some cases been sprayed into the pin-one cavities, with the result that the cavities in close optical view appeared roughly textured rather than perfectly flat and smooth. FIGURE 2 is a SEM image of a portion of one pin-one cavity that has been partly sprayed. Some cavities, however, were completely clean and resembled those found in genuine parts.

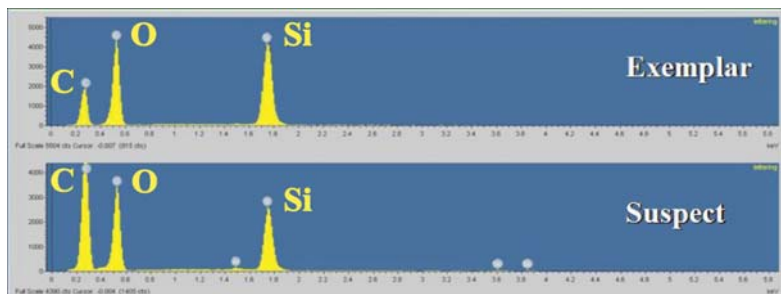
EDX analysis compared the results of the new blacktop material with analysis of the top surface of known genuine components. The results (FIGURE 3), while not identical, suggest it is possible that the sprayed-on blacktop had its origins in the dust created by sanding genuine components.

FIGURE 3. Spectrum analysis shows similarity of genuine component and highly engineered blacktop material. (Tescan USA)

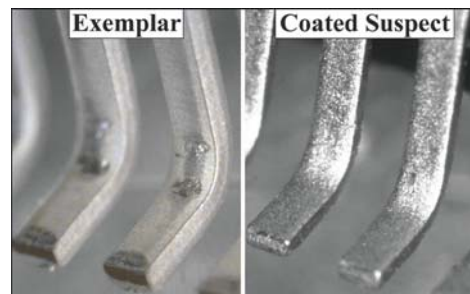
Another clue was found in the leads of the components. At left in FIGURE 4 is a light microscope view of two leads from a genuine component. Because these leads were straight when coated, the forming process produced some cracking or scaling of the coating

FIGURE 4. Surface scaling at bend in genuine leads (left) is concealed by counterfeit plating (right).

at the bend. This is an expected feature on genuine components. But counterfeiters apply coatings to leads that are already bent, so cracking and scaling are absent. The coating applied by counterfeiters also rounds off the lead ends and conceals the copper base metal visible in the cut-off lead ends on the genuine parts.

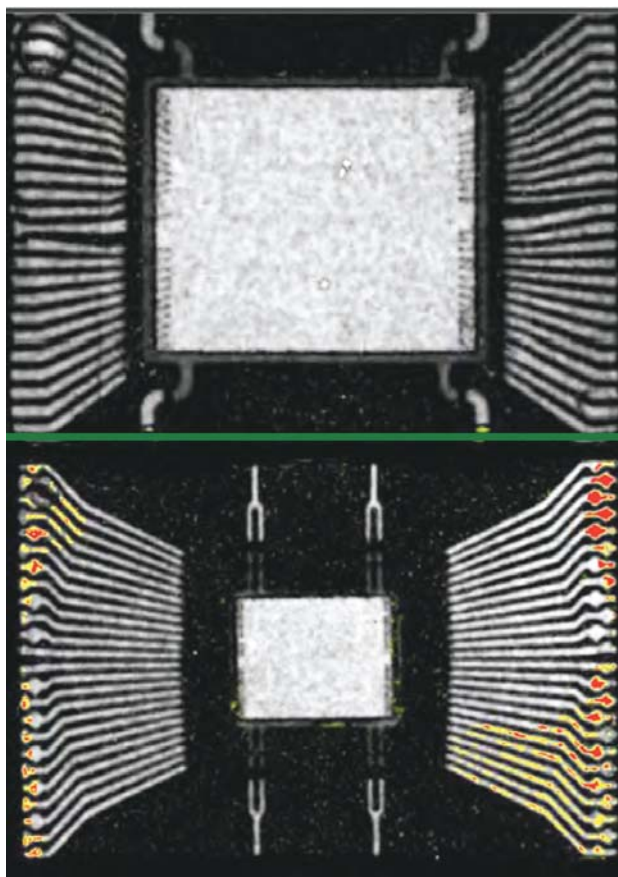
FIGURE 6. Close to identical in visual appearance, these two parts held internal surprises when imaged acoustically. Fake component is at bottom.

When an acoustic micro imaging system targets a specific depth within a counterfeit, strange things are sometimes found. FIGURE 6 shows two outwardly identical components having the body dimensions, the same label and the same number of leads. But the acoustic image shows that the component at bottom is either a newer die revision from the manufacturer utilizing a smaller die or is from a different component manufacturer altogether and uses entirely different die and lead frame. It also has small delaminations (red and yellow) on nearly all of the lead fingers.

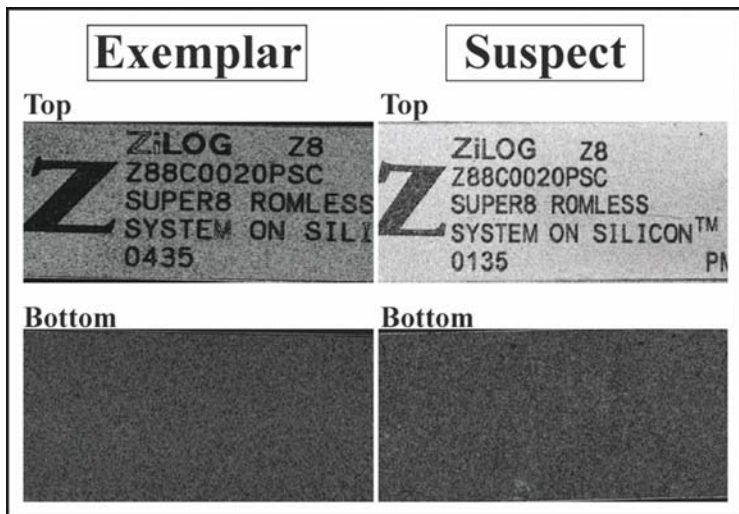
material during the same injection molding process. But in a recycled fake where the top has been blacktopped, the two sides often look very different. (FIGURE 5).

FIGURE 5. Acoustic micro imaging of surface of counterfeit component shows differences in material properties between top and bottom.

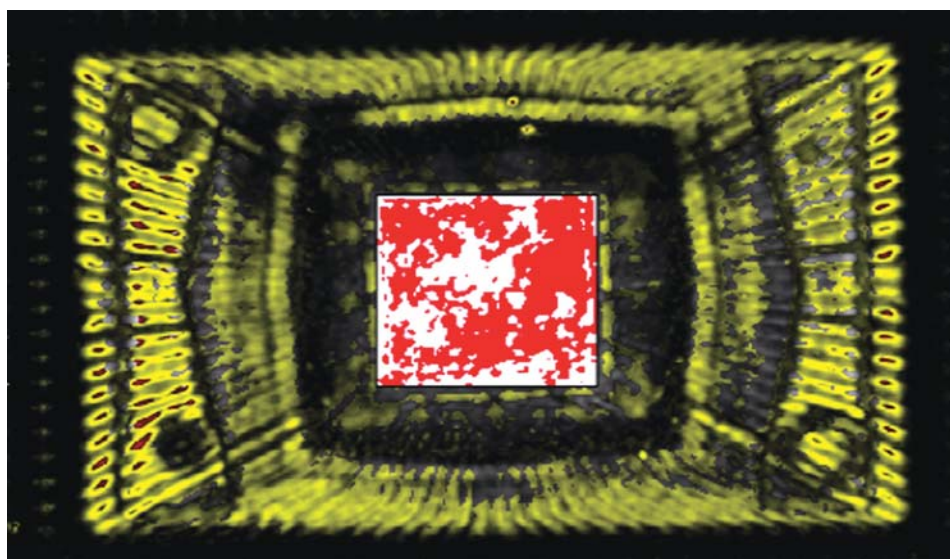
One of the areas of interest in any acoustic image of a component is the percentage of delaminations or similar defects in the die attach material. For example, J-STD-020D, sec. 6.2.1.1, specifies that metal lead frame components may have “no delamination/cracking >50% of the die attach area in thermally enhanced packages or devices that require electrical contact to the backside of the die.” New, genuine components may have some percentage of delamination and be perfectly acceptable for most applications.

Recycled components may show a relatively greater degree of delamination, presumably because of the thermal and mechanical stresses of prior use and of the counterfeiting process itself. **FIGURE 7** shows the acoustic image of a known counterfeit component whose die attach delaminations (red areas) exceed the standard. Digital image analysis showed delaminations covered 57.12% of the die attach area.

FIGURE 7. Red areas seen acoustically are >50% delaminations in die attach in counterfeit component.

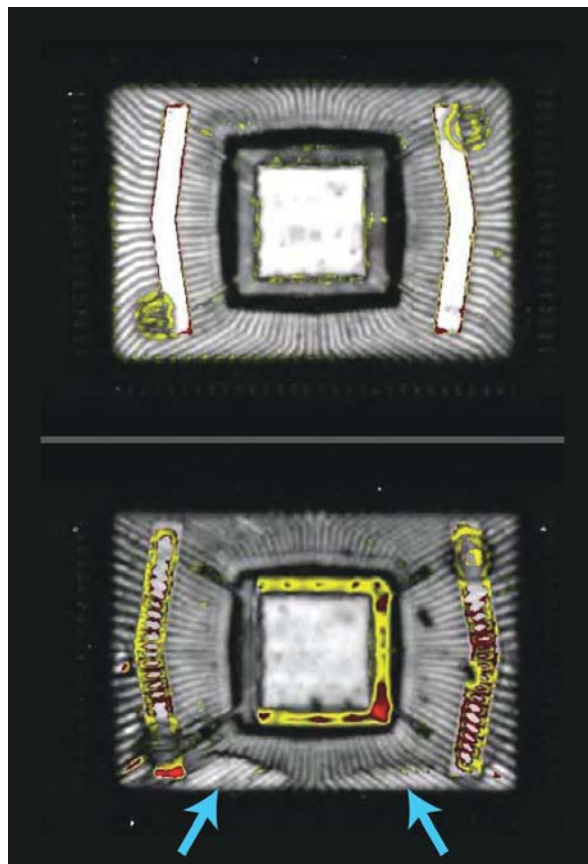
Collaboration between SMT and Sonoscan has resulted in the identification of internal features not previously seen acoustically in components. **FIGURE 8** is the acoustic image of a pair of components. The genuine part at top shows minimal defects. The recycled counterfeit at bottom shows numerous delaminations (red, yellow) on the die paddle and on the tape. But it also shows a surprising feature: two over-bright regions (arrows) near the bottom edge. Something has happened along this edge to make the interface between the mold compound and the lead fingers appear brighter than elsewhere, and the upper edge of this phenomenon is marked by a dark line. Two possible explanations: Sanding may have altered the top edge of the component, causing the returning ultrasonic echoes to bend; or heat may have re-cured or otherwise altered the mold compound in this region, but without creating a gap (delamination), which would be red or yellow. Strange effects seem to occur when components are subjected to heat, mechanical shock and moisture in uncontrolled environments.

FIGURE 8. Component at bottom has novel acoustically imaged anomaly (arrows) seen only in counterfeits.
