Counterfeit Electronic Components Identification: A Case Study

by **Martin Goetz and Ramesh Varma**
NORTHROP GRUMMAN CORP.

Background on Case Study

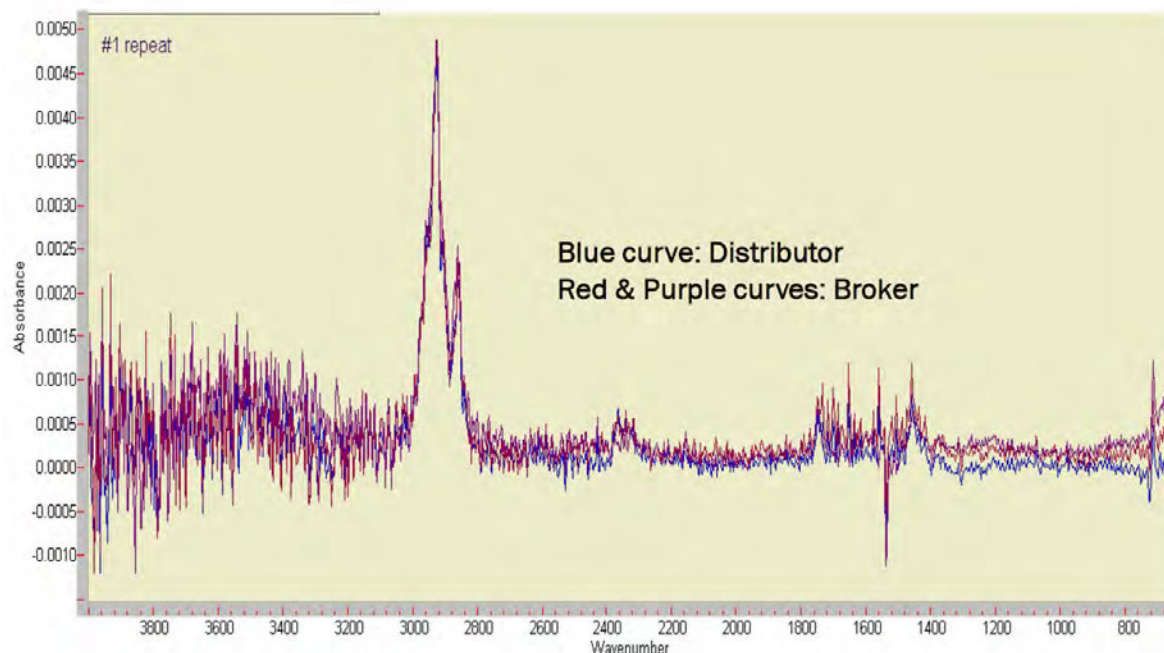
ously collects high spectral resolution data over a wide spectral range. This confers a significant advantage over a dispersive spectrometer, which measures intensity over a narrow range of wavelengths at a time¹⁰. For this evaluation FTIR was used to evaluate the integrity of organic mold compound. When a blacktopping process is used to re-mark previously used parts, FTIR provides the ability to distinguish between two different materials. The materials that comprise the component body and any blacktopping material used to hide the evidence of counterfeiting are all organic polymers. As indicated by the spectroscopy measurement in Figure 7, there is a clear difference in response between parts. Using the distributor part as the baseline, the response from the broker parts suggests a different material is present. Blacktopping material is added to the baseline material and therefore would create a different response from the baseline. This measurement is one more indication of inconsistency between two different supplier parts.

Figure 7: FTIR spectroscopy graph. Blue identifies mold compound spectra as received from distributor, red and purple from broker.
